SEPTEMBER 2020 • POWER GENERATION

FAULT RECORDING IN A UK UTILITY

Deployment and Performance of a Large Scale Fault Monitoring System During Storm Conditions David Cole, Peter Glover, Qualitrol Corporation

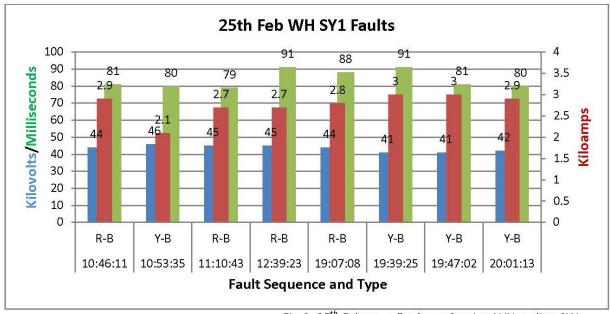
Fig 3 25th February Faults at Station WH on line SY1

Fault and triggered slow scan records from the relevant recorders were analyzed to examine the fault activity in more detail. Fig 3 shows the minimum voltage, maximum fault current and clearance time for each of the 8 faults at WH substation on the SY1 circuit. As can be seen all were cleared successfully in 79 to 91ms with fault currents ranging from 2.1 to 3KA. Fig 4 shows a similar situation for 8 of the 9 faults at substation SL on the SY circuit. However, the first fault of the day had a fault clearance time of 8 seconds indicating a sticking circuit breaker. Subsequent circuit breaker operations were successful. This will be analyzed in more detail later.

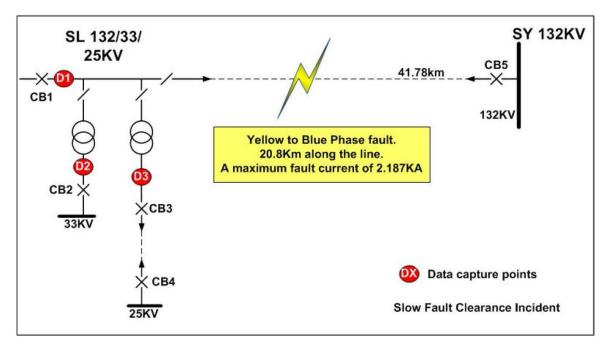
Fig 6 Basic network diagram of fault

The first fault of the day that occurred on the 25th on the SL to SY line was only partially cleared by the protection. The fault was a phase to phase fault caused by snow loading on the line and high winds. A more detailed single diagram of the network is shown in Fig 6. CB1, CB5 and CB3 all operated within 120ms of fault inception, however CB2 remained closed and continued to back feed the fault until it self extinguished almost 3 seconds later. A further 5 seconds after this CB2 finally operated.

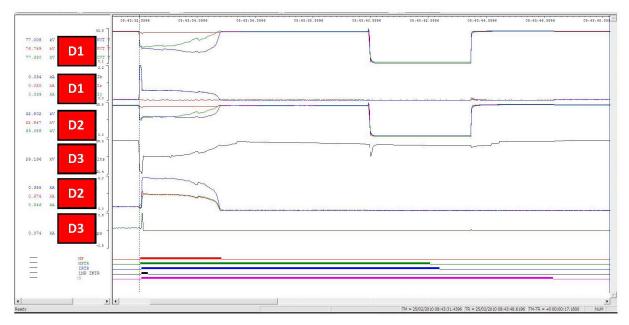
Fig 7 TSS Record showing full fault duration and Auto Reclosure

The triggered slow scan record from SL (Fig 7) shows the full duration of the event from fault inception to the successful auto-reclose approximately 12 seconds later. Note that the phase current measured at D1 is the summation of the line current and the 2 HV transformer currents. Only single phase quantities are available from D3. The record shows fast clearance of the main fault current by operation of breakers CB1, CB5 and CB3. However reduced fault current continued to be fed into the fault from the closed D2 circuit breaker. The current reduced to zero after 3 seconds when the phases parted and the arc extinguished but CB2 did not open until another 5 seconds had elapsed collapsing the volts measured at D1. CB5 auto reclosed after 12 seconds and CB1 after approximately 15 seconds.

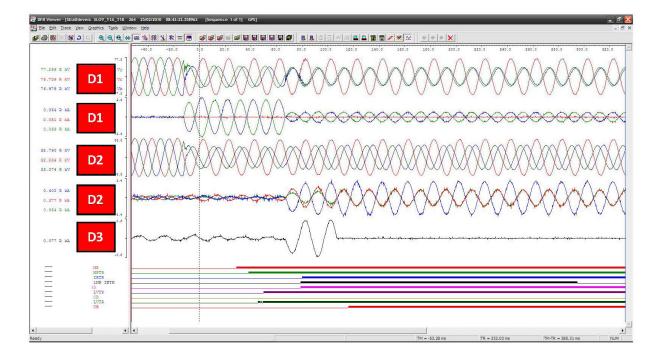
Fig 8 DFR Record of Fault Inception

It would not have been possible to fully analyze this event using fault records from the relay as the record lengths would have been too short. The high speed fault record shown in Fig 8 shows the initial events at fault inception. The effects of the delay in the operation of breakers CB1 and CB3 can be clearly seen. The continuing current at D2 clearly shows that the breaker has remained closed. Note that to obtain this record from relays would have meant downloading and merging 3 separate records assuming they were all time synchronized. All the data is in one synchronized record in the stand alone recorder making analysis much easier and quicker.

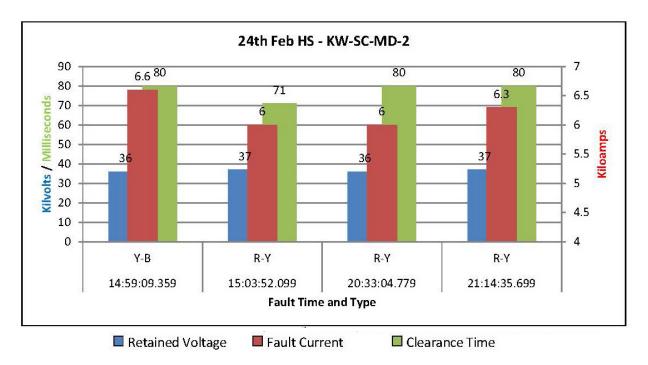
There were faults on 2 different voltage levels 132KV and 33KV. Fig 9 below shows an overview of the faults that occurred on the KW-SC-MH-2 line at HS. All fault clearances looked to be successful.

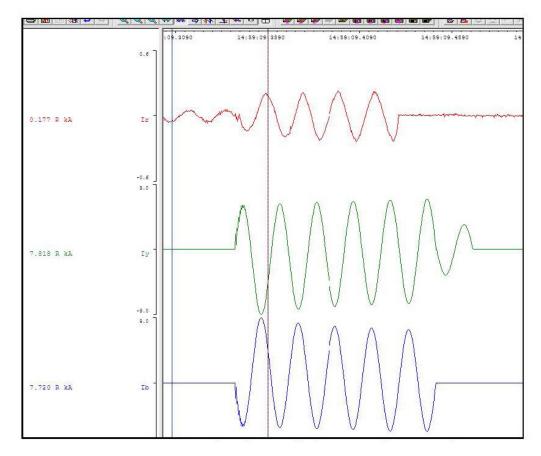
Fig 9 Circuit Breaker clearing fault current showing pole stagger

Detailed examination of the first fault at 14.59 revealed excessive pole spread when the circuit breaker operated. Note that the red phase trace has been magnified and is on a different scale to other phases.

It can be seen that each of the current reduces to zero at a different time. The red phase is the first to be extinguished, then the blue phase 20.16ms later and finally the yellow phase a further 20ms later. This resulted in a large spike in residual current which latest for a cycle. See Fig 10.

Note that the same effect was not seen in subsequent operations suggesting that it was caused by a sticking mechanism cleared after the first operation. It does suggest maintenance is required.

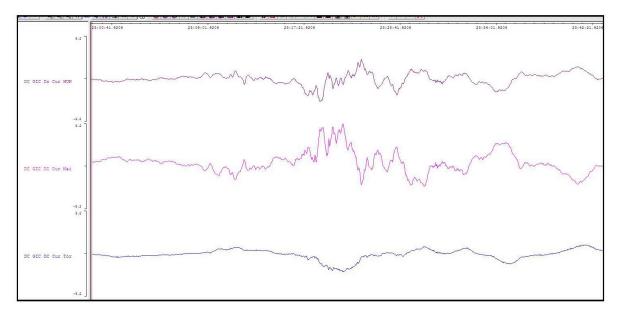
Fig12 GIC Data

Fig 12 below shows some recorded data from the one of the Utility's GIC monitors. During this storm there were burst of GICs that lasted for minutes peaking at 13Amps. During sustained storms the Utility takes steps to reduce transformer load to avoid overheating.

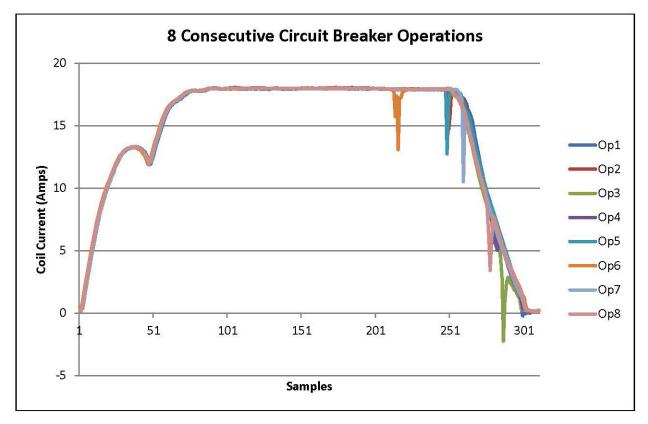
Fig 15 Circuit Breaker trip coils from 8 operations

Eight profiles from consecutive circuit breaker operations from the 25th of February at substation WH for the SY1 line show no significant differences apart from some spikes on the current decay that could be caused by arcing on an auxiliary contact. Changes in the latch mechanism or breaker operate time would result in a different shape.

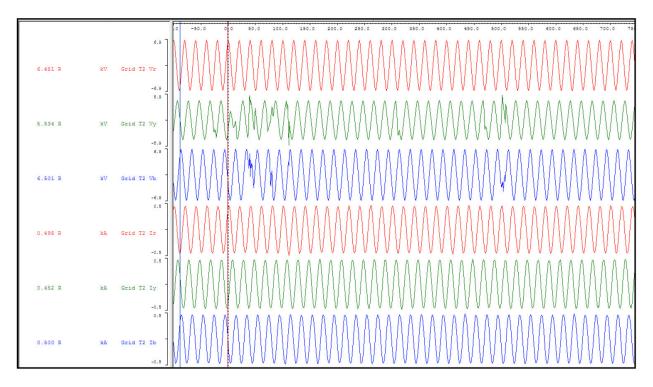
Fig 16 CVT Issues Captured by the Recorders

Another phenomena recorded by the Fault Monitoring System during the February storm were several CVT perturbations as seen in the voltage traces in Fig 16.

The recorder triggers on under voltage otherwise the Utility would not know this was happening. It would certainly not be detected by a relay. The cause is transient operation of the over voltage protection circuit on the secondary of the CVT. It has been detected on many different types of devices and if it gets too repetitive or severe then a line outage is organized and CVT maintenance undertaken. If left it could result in the loss of one or more phase voltages that would drastically affect protection performance.
