HOUR BY HOUR CHANGES: CATCHING A DEVELOPING FAULT

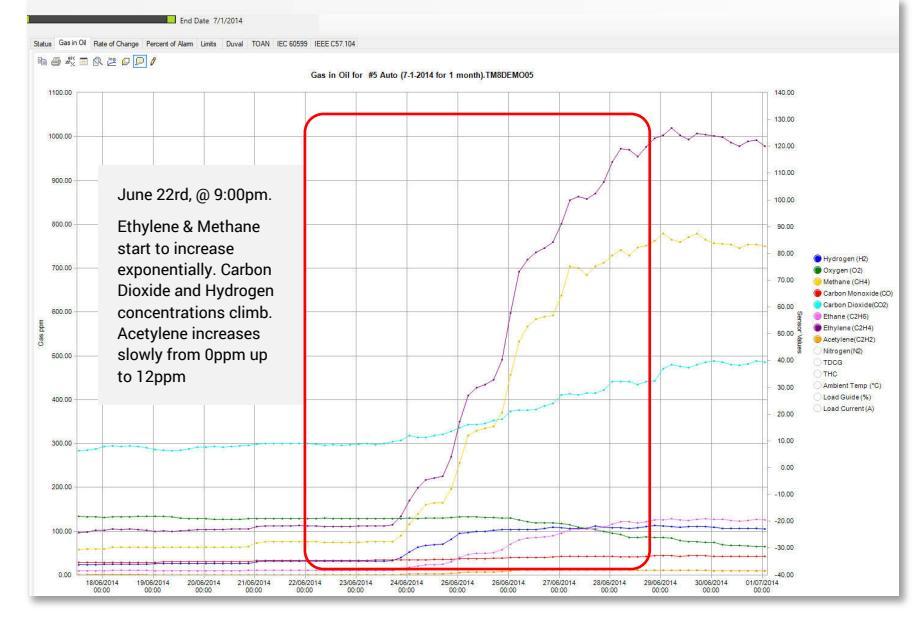
At 1:00am on June 23, 2014, the TM8 alarmed for Rate-of-Change increases in concentration of Ethylene (C2H4) and Methane (CH4) both of which had been elevated but stable for several months. Over the next 5 days the operator kept the transformer under load for operational purposes and carefully monitored all gases. When Acetylene (C2H2) climbed to an actionable level (10ppm) the transformer was taken off-load.

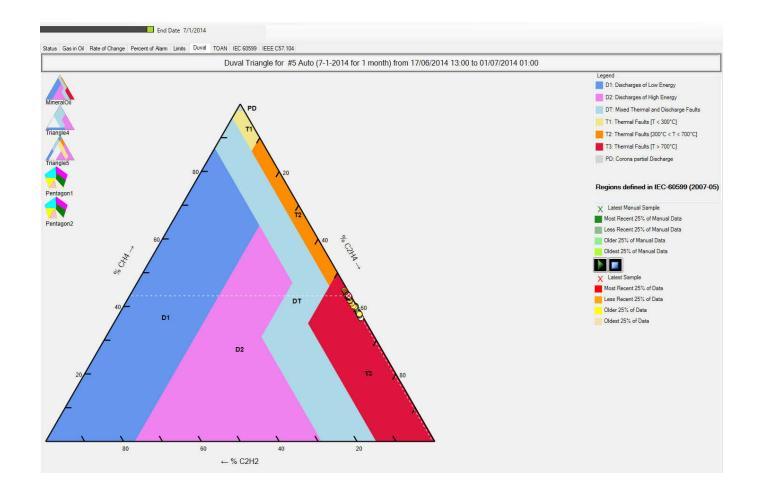
Reviewing the load data around the time of the increasing gas generation rate it was observed that the transformer had been heavily loaded at the time, also that increasing load correlated well with increasing gas production. Reviewing the DGA data with Serveron TM View software, Duval Triangle 1 indicated high temperature overheating (Figure 1) while Triangle 5 indicated medium to high temperature hot spots (Figure 2).

Figure 1: TRIANGLE 1. Thermal Fault >700oC

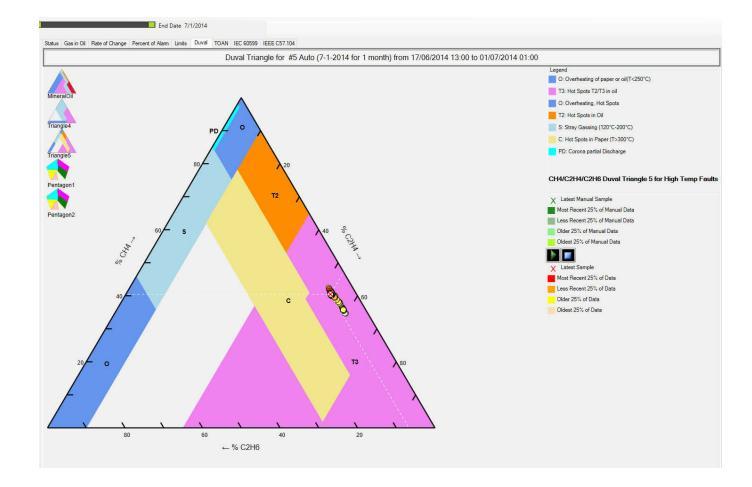
Figure 2. TRIANGLE 5 Hot Spots T2/T3 in oil
