SEPTEMBER 2020 • POWER GENERATION

FAULT RECORDING IN A UK UTILITY

Deployment and Performance of a Large Scale Fault Monitoring System During Storm Conditions David Cole, Peter Glover, Qualitrol Corporation

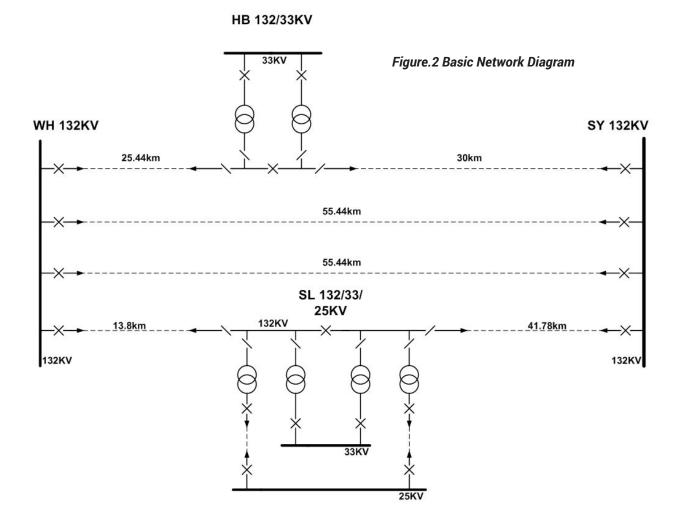
A single line diagram of the 132KV network is shown below in Fig 2. Most of the faults occurred on 3 lines.

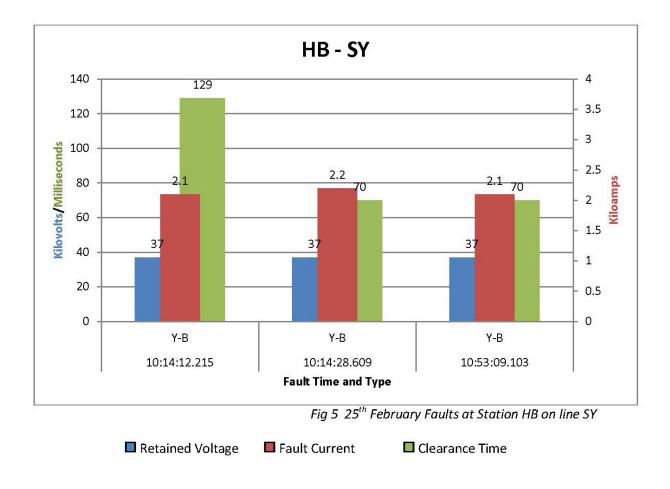
Fig 5 shows the results for the 3 faults at substation HB on the SY circuit. Note the relatively slow clearance time of 120ms for the first trip as opposed to 70ms for the next two. Fault current and minimum voltages were similar for all three faults indicating a slow first trip of the circuit breaker.

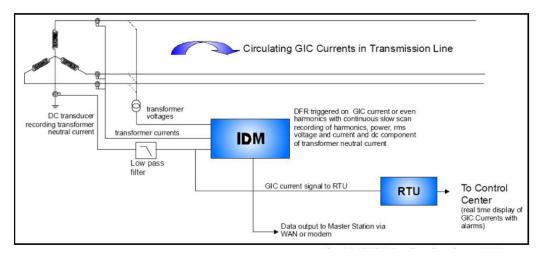
Fig 11 GIC Monitoring in a DFR

Geomagnetically induced currents flowing in a transformer can be detected in the ground point of the transformer and the result of saturation within the core can be detected by measuring even harmonics in the transformer currents. Figure 11 shows how a multi-function recorder can be used to detect and record geomagnetically induced currents.

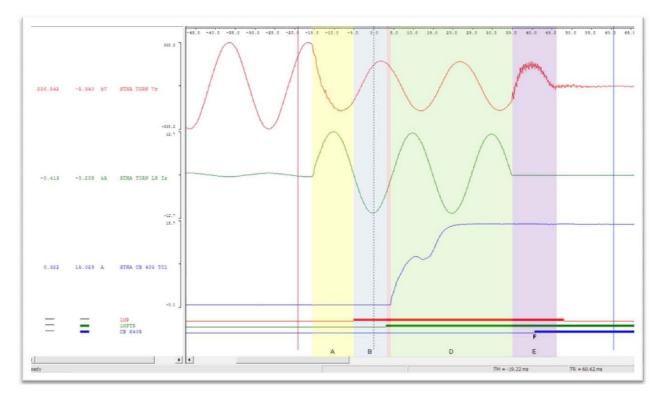
Fig 13 Fault with Trip Coil Current Profile

The versatility of a stand alone fault recorder makes it ideal to monitor circuit breaker performance. By adding the trip coil current, DC battery voltage and some extra auxiliary contacts it is possible to emulate the function of most dedicated on line circuit breaker monitors. The Utility has done this and an example of a trip operation showing trip coil current and auxiliary contact operation is shown in Fig 13. Fig 14 shows the entire record with all analog and digital channels.
